Case study “Propeller Bulk Carrier”

This study describes the problems of fouling on propellers in general, the installation of our system on this vessel and the results observed after 8 months since installation was completed.

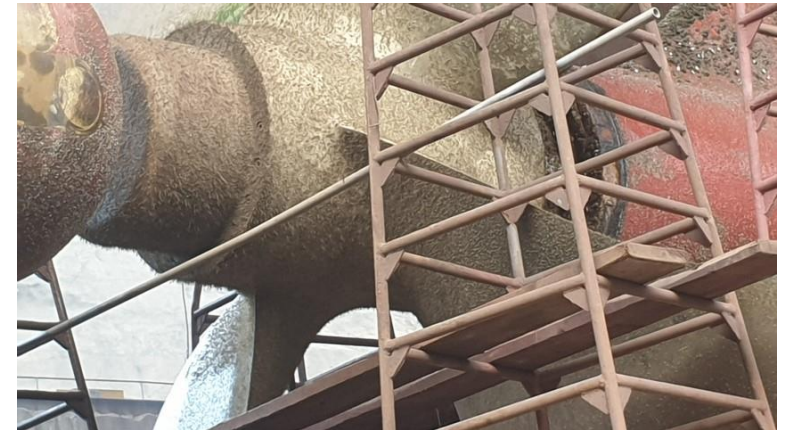
Fouling on the propeller can lead, in the most extreme cases, up to an efficiency loss of more than 30% compared to the performance of a smooth, fouling-free propeller. Even a small amount of fouling is already noticeable in the fuel consumption. Biofouling therefore has a direct impact on operational costs.

Fouling on propeller

In many cases, fouling is removed with a high-pressure cleaner when the ship is in dry dock. If the ship cannot wait until the next dry dock, propellers are also regularly cleaned under water. Fouling on the propeller is an inevitable problem for some vessels in sensitive conditions after just three months. This maintenance costs money and has long term disadvantages for the propeller's performance.

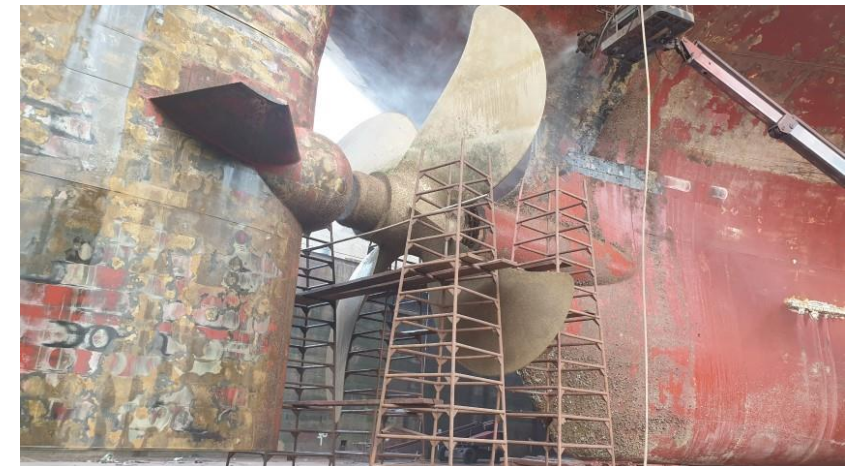
In this case study we will cover the propeller of a large bulk carrier. The propeller of this vessel has a diameter of 8,4 meters. The vessel was experiencing fouling on their propeller which lead to unnecessary maintenance costs.

Propeller of large bulk carrier

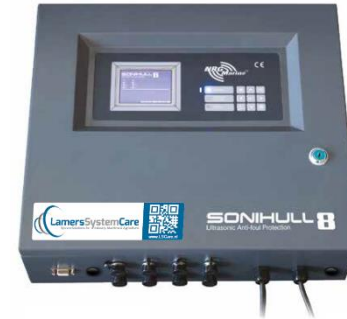
The Ultrasonic Anti-Fouling system consists of a control box and one or more transducers. These ensure that an ultrasonic sound wave is created on the surface of a construction. This leads to bubbles forming at a microscopic level, which then implode with force and thus combat the first phase of fouling: the adhesion of single-celled organisms that together form the layer of biofilm. By preventing this layer of biofilm, multicellular organisms, such as larvae of mussels or cockles, have no chance to attach themselves to the surface. This makes the Ultrasonic Anti-Fouling system a preventive, environmentally friendly and sustainable solution.

SH08 control box

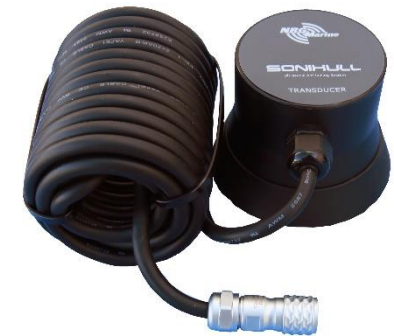
SH08 Transducer

For the installation on this vessel, the SH08 system was used once, with 8 transducers. Four transducers were installed on the Aft stern tube bearing and 4 transducers on the intermediate bearing.

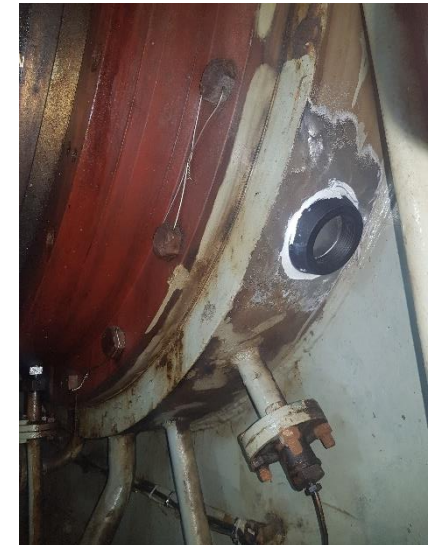
Correct installation is essential for a good transmission of the ultrasonic signal. The installation itself is not difficult, but locating the transducers and gluing the rings require careful attention. For this part of the installation we advise to always contact Lamers System Care.

Glued transducer ring on stern tube bearing

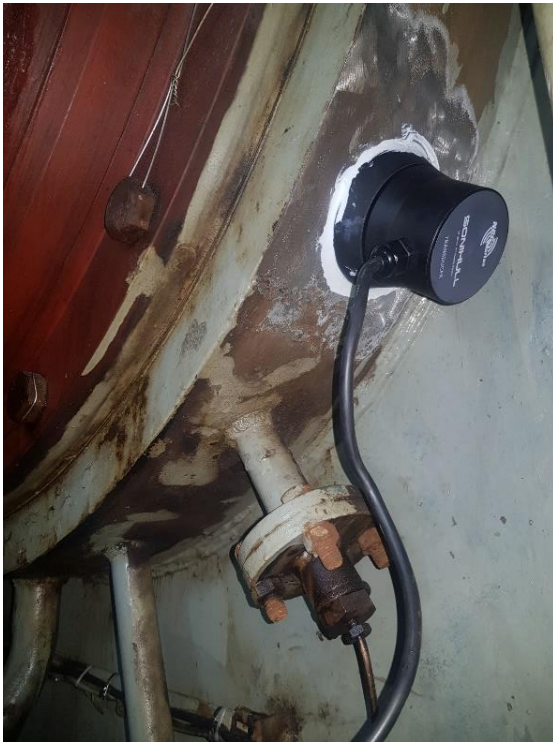
Transducers on aft stern tube bearing

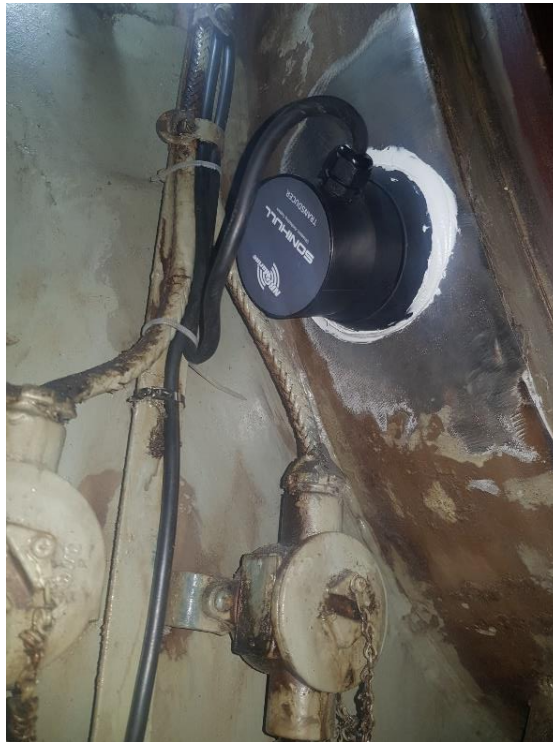
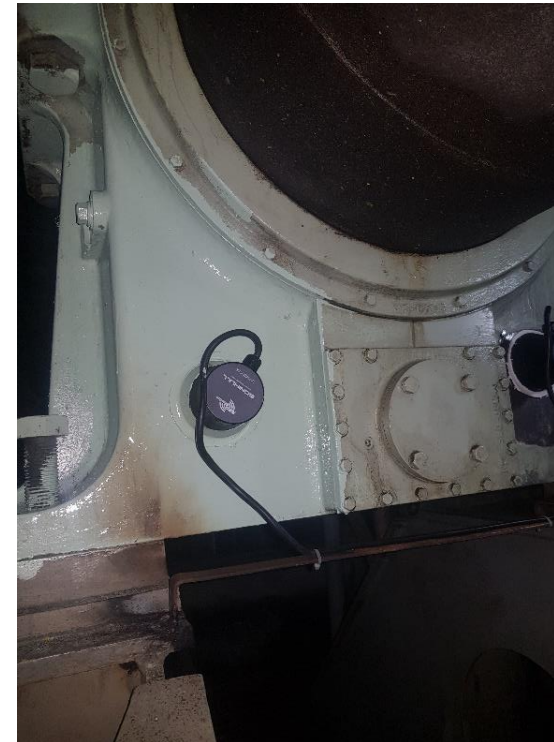
Transducers on intermediate bearing

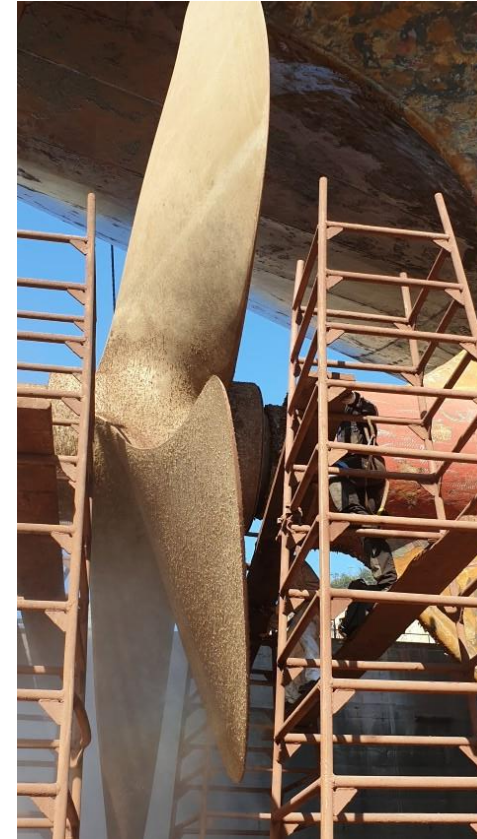
About 8 months after installation, the vessel went into dry dock and the propeller could be inspected. During this inspection, the customer was relatively satisfied with the result.

As can be seen in the images, the screw has no hard fouling (shells, barnacles etc.) on the blades, only some seagrass, which can be removed easily.

On the boss of the propeller some small fouling can be seen. According to the customer this was quite easy to remove.

Propeller after installation Ultrasonic Anti-Fouling system
