Case study “Seawater inlets, strainers and crossover”

# The problem

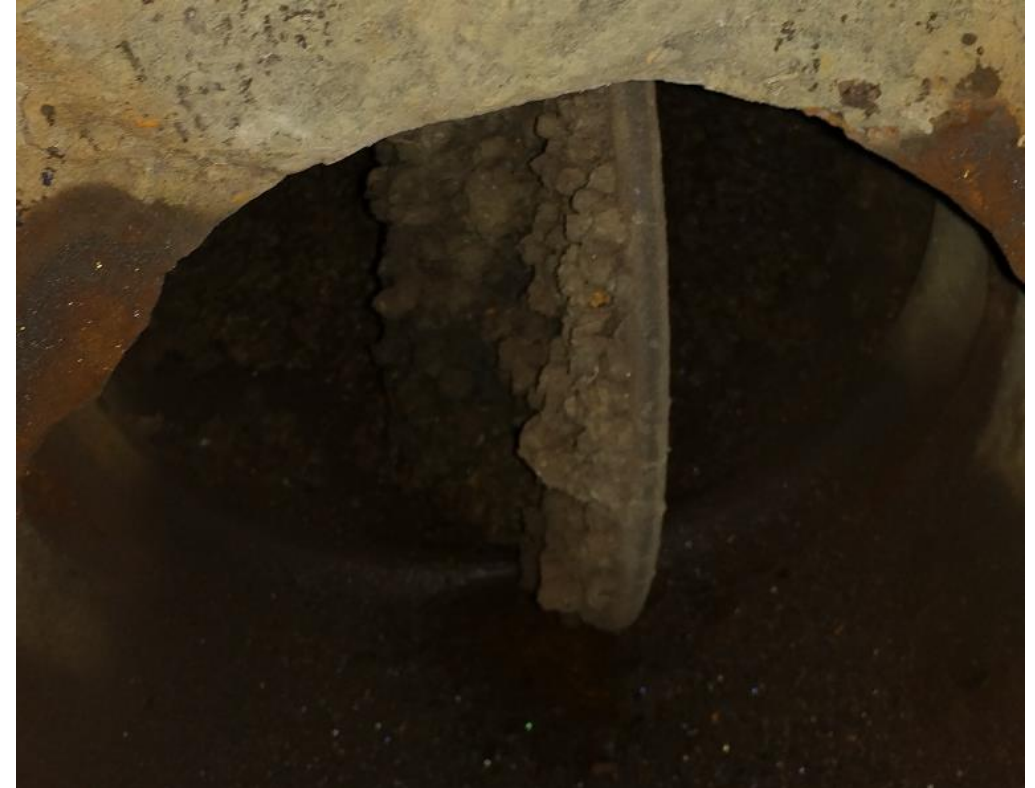
There is a curious phenomenon: large mussels in the crossover, which cannot pass through a seaweed pot. How is it that such an amount of fouling is still present, behind the filter? The photo is a representation of the inside of the crossover, after a valve.

Bacteria and other organisms are carried along by the flow through the cooling installation. The strainer functions as a filter, but does not collect these tiny particles. For example, larvae of mussels, for example, flush with the seawater through the holes in the filter and attach themselves to the inside of a crossover. Then these grow into adult mussels.

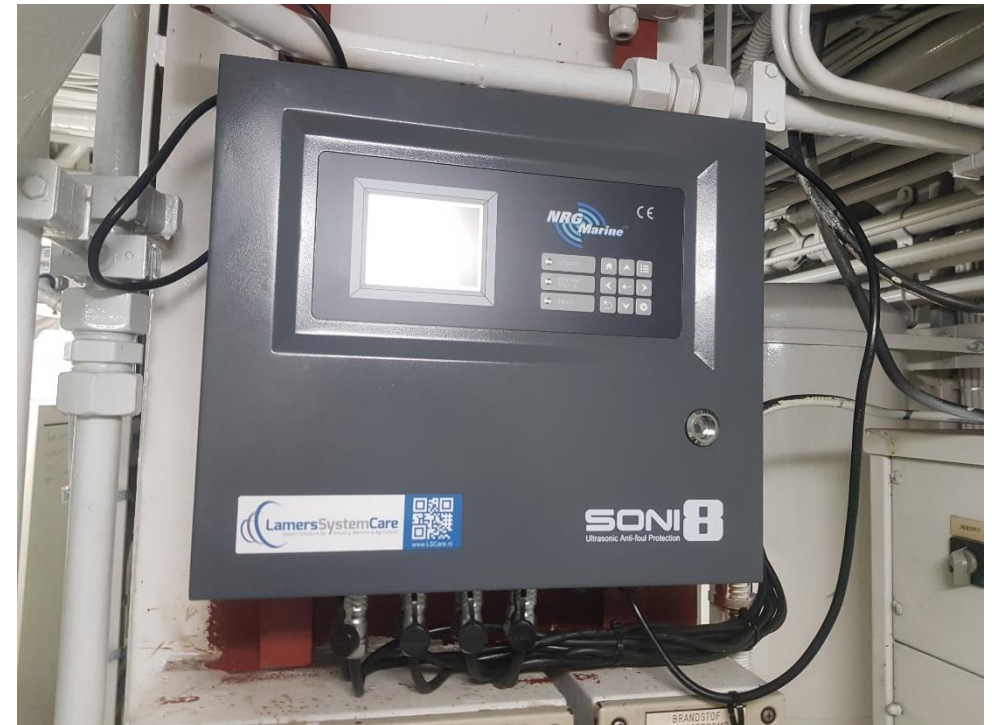
The Sonihull8 control unit can be connected to both 110-240 VAC and 12-24 VDC. If both are connected, the system automatically selects the VAC (shore voltage) and when this is lost, the system automatically switches to the VDC. If the battery voltage becomes too low, the system switches off automatically to save the battery.

The control unit is programmed in such a way that the transducers run the same program every time. As a result, the transducers produce pulses every few seconds with a range of frequencies between 20 and 60 Kilohertz that are not audible to the human ear. When this program has been completed with 20 different frequencies, the program starts again.

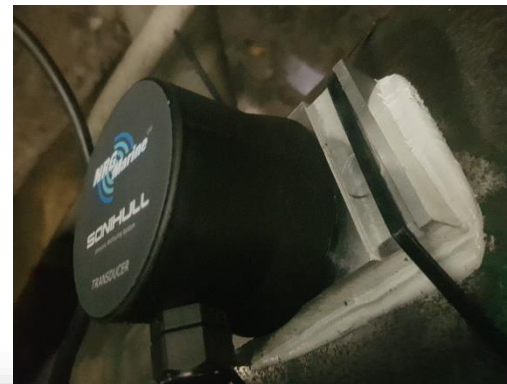
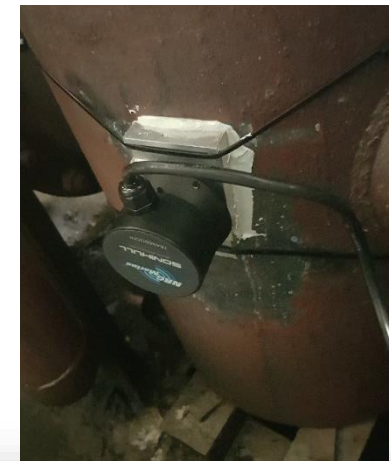
The transducers consist of a piezo element that is enclosed in a housing produced by means of injection molding. The transducer is then screwed into a pipe adapter or transducer ring with some Molykote BR2+ (industrial grease), which is glued with a strong two-component epoxy.

In this case the pipe adapters and transducer rings are glued on a crossover, strainer and seawater inlet. Because the bottom of the transducer is not glued to this surface itself, but the ring or pipe adapter is, the transducer uses this ring or PA as a grip so that it can distribute firm taps with its impulses.

This is many times stronger than a transducer that is itself glued to a surface. This results in a better sound transmission, so that the surface is brought into resonance better and thus a stronger effect of the ultrasonic effect takes place.

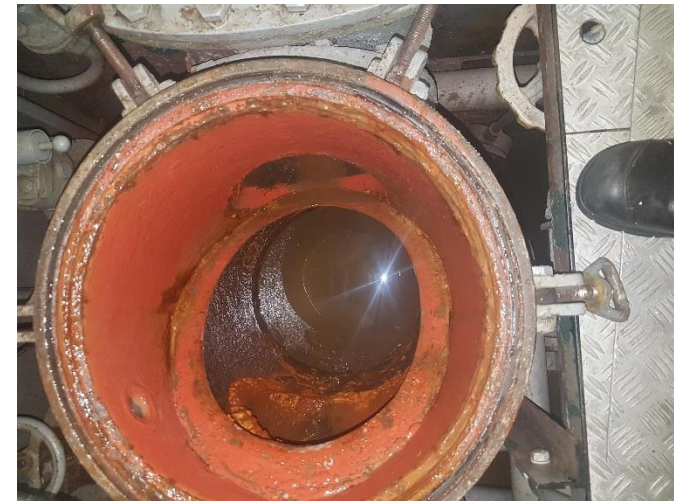
Where the tug regularly had fouling in its crossover and strainers after 3 months, this has not been a problem for at least 13 months after the Ultrasonic Anti-Fouling System has been installed.

The installation has ensured that the tug's engines and auxiliary systems remain efficiently cooled with seawater, there is no loss of cooling capacity over time. This ensures that the lifespan of the engines and other systems is extended and that less maintenance is required on the cooling system. This effectively reduces the number of dry docks for this tug.

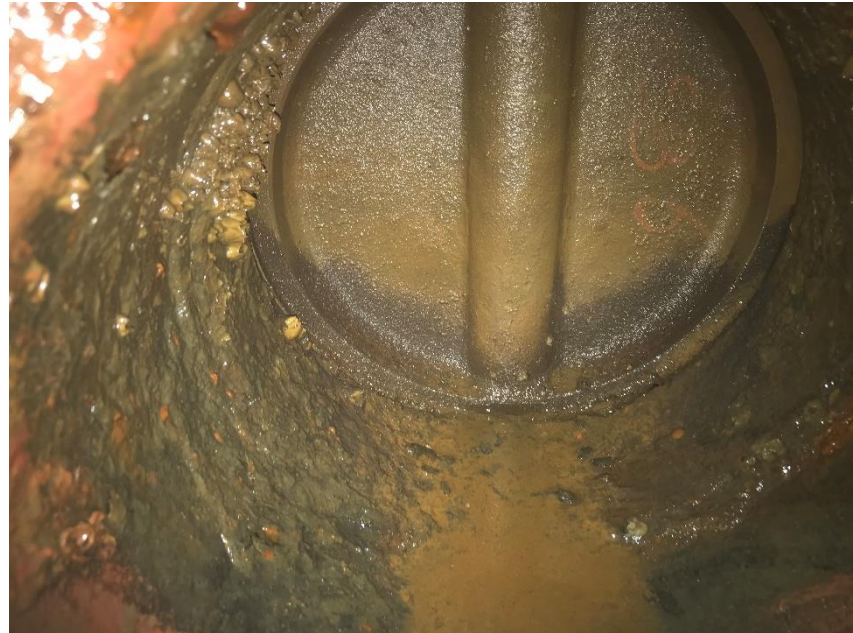
Strainers during the 2 different inspections (December 2019 and September 2020).

The only fouling that can be seen is a remnant of the fouling that was already there before the Ultrasonic Anti-Fouling system had been installed. As can be seen in the pictures, this growth has not worsened in 10 months.

*Strainer December 2019*

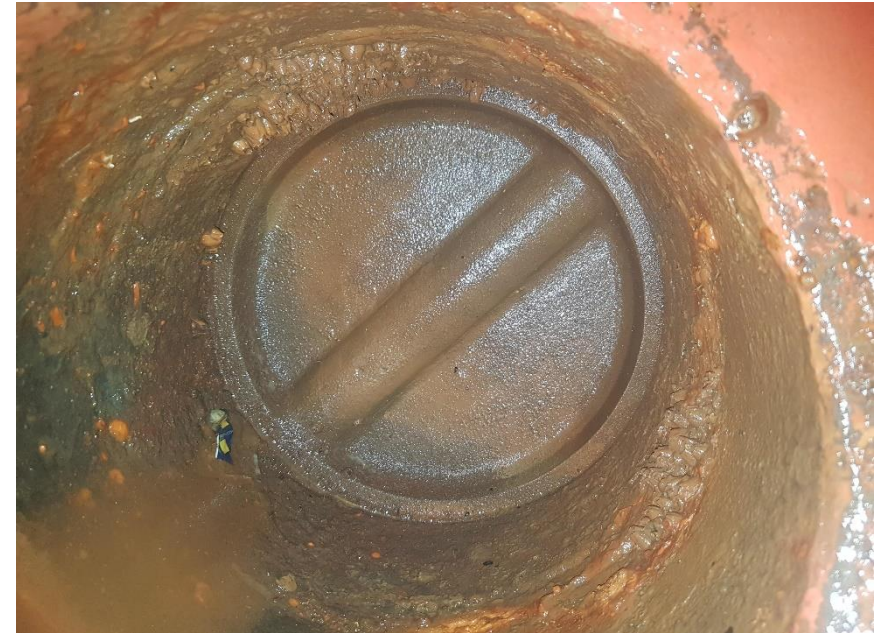
*Strainer September 2020*
