## ENDURES - RPT19027

Field efficacy test of environmentally friendly antifouling products for pleasure boats in The Netherlands.

| Project name | HISWA Praktijktest antifouling |

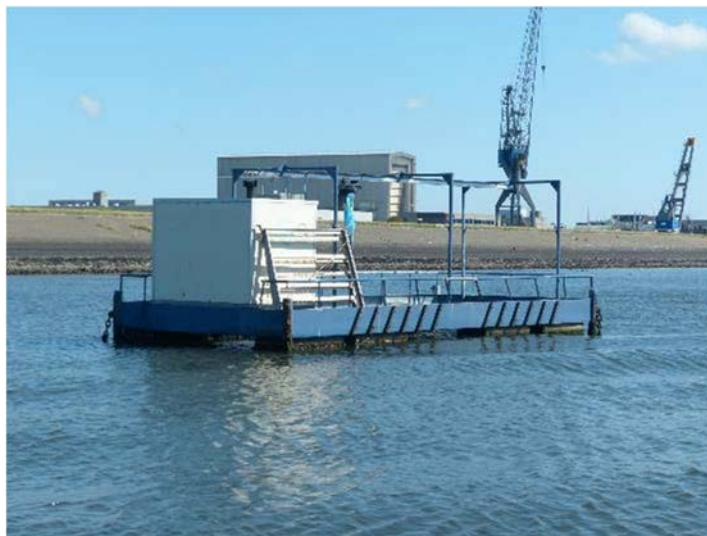
The static exposure test was carried out at the raft of Endures in the harbour of Den Helder (see Figure 1). In this harbour natural tidal currents occur that vary between 0 and 2 knots. Distance from the shore is less than 50 m and water depth at the position of the raft is at least 8 m.

Figure 1. Raft exposure facility of Endures in the harbour of Den Helder, The Netherlands

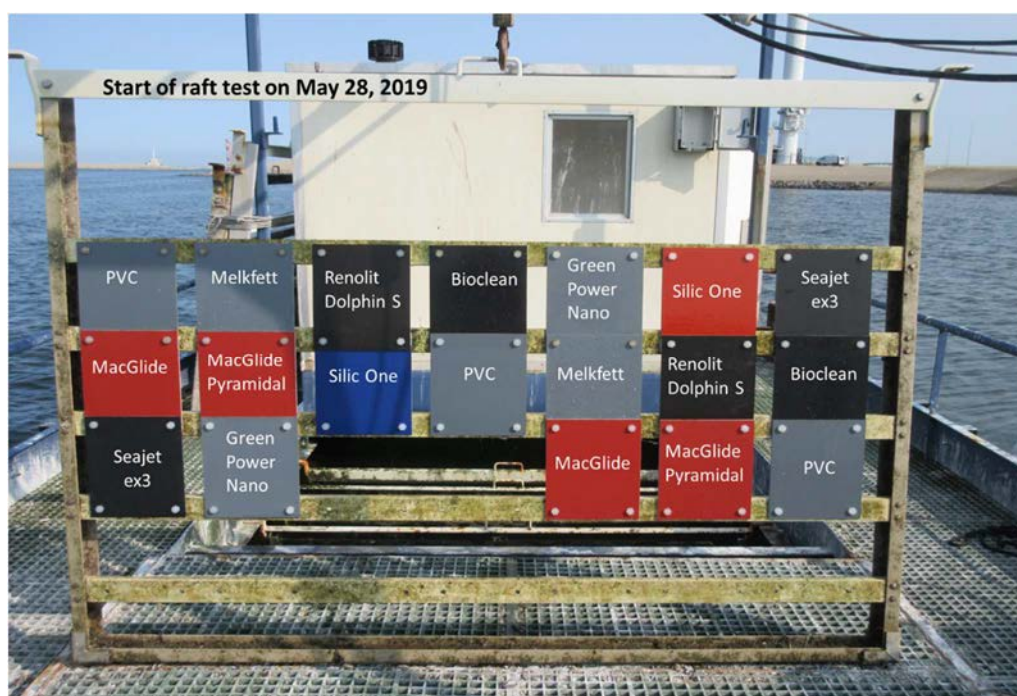
Panels with coatings and foils were mounted onto one of the exposure racks of the raft facility. In Figure 2 the rack with (almost all) panels is shown prior to immersion. At a later date (July 3, 2019) two more panels with the product Finsulate were added to this exposure rack. The product Ecospeed was not involved in the raft test.

Figure 2. Panels with antifouling products prior to immersion at the raft of Endures.

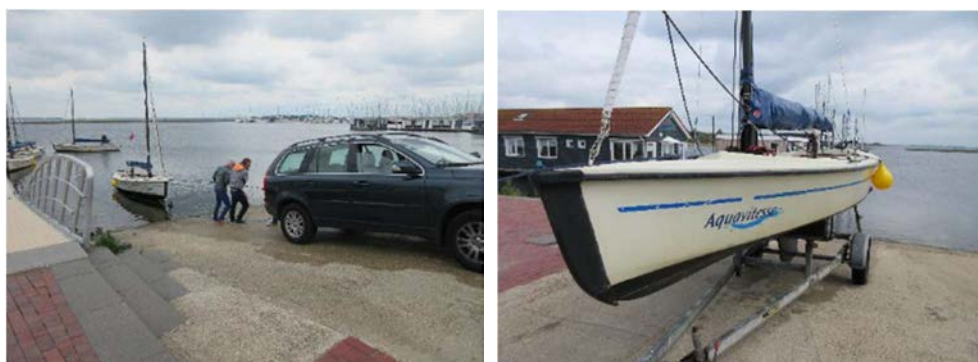
Figure 5. Boat lifting procedure for small boats ("Valken") at Aquavitesse in Bruinisse.

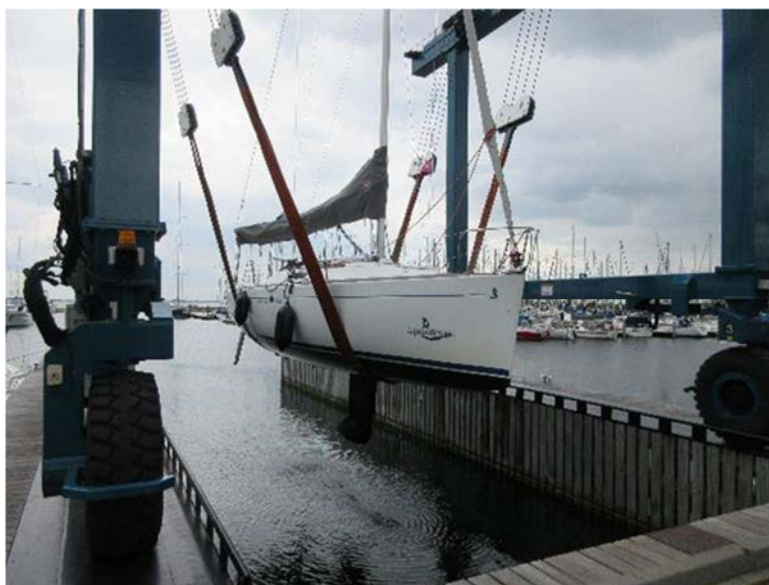
Figure 6. Boat lifting procedure for larger yachts at Aquavitesse in Bruinisse.

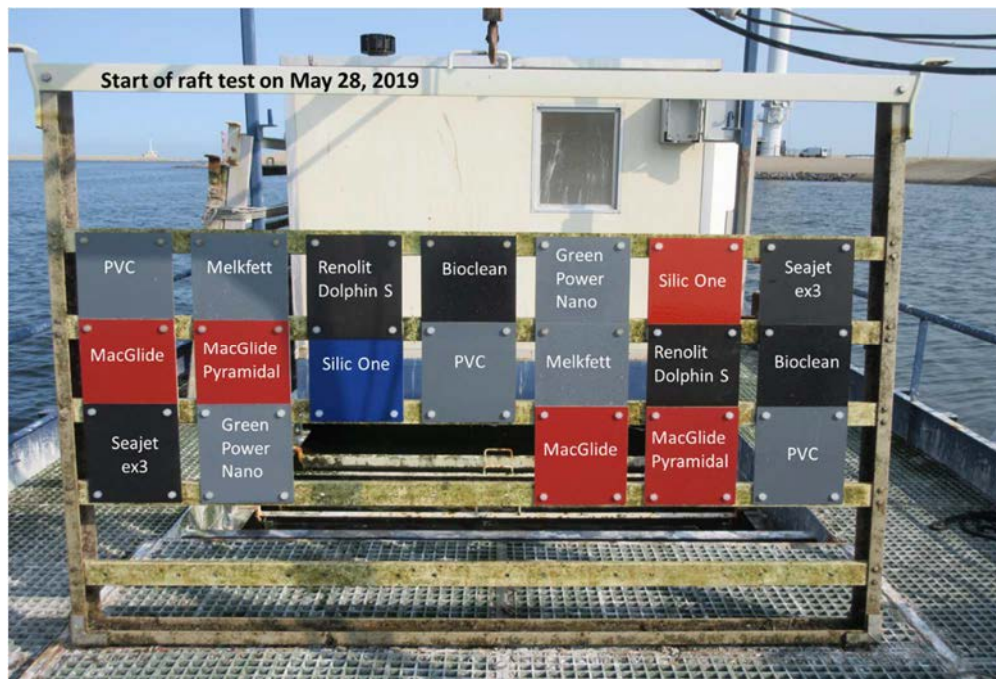
Starting condition of the raft test is shown in Figure 7. Each product is applied on two panels and duplicate panels of products are exposed at different depths.

Figure 7. Panels with antifouling products prior to immersion at the raft of Endures.

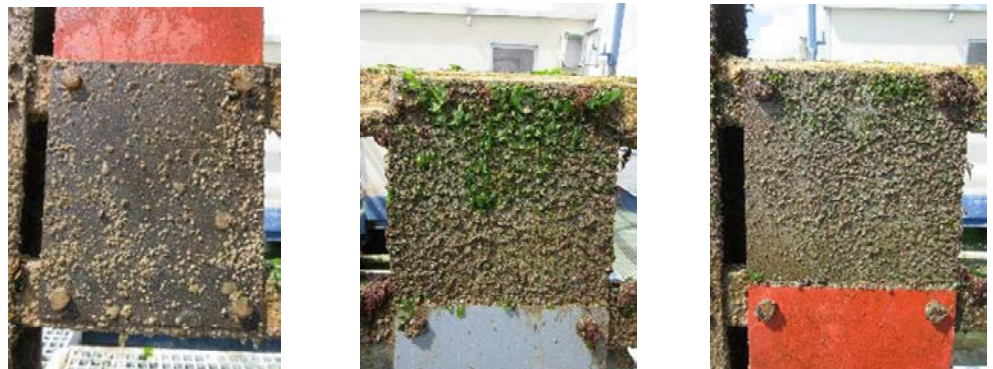
For comparison the fouling condition of one of the blank PVC panels (top row left) is also shown in Figure 9. Here similar number of adult barnacles are found as on the other two products.

Chugoku as supplier of product Seajet ex3 has further investigated the results of this product and found out that on both panels the topcoat was not the self-polishing coating layer as it should have been. Apparently the wrong topcoat was applied here being the reason for the bad performance of both panels.

Figure 9. Detailed pictures of panels with Seajet ex3, GPN and blank PVC (from left to right).

Two paint systems, e.g. Green Power Nano and Seajet ex3 have failed to demonstrate any antifouling effect in this raft test. Investigation by Chugoku revealed that the failure of product Seajet ex3 could be attributed to a mistake made during application of the test panels for this raft test.

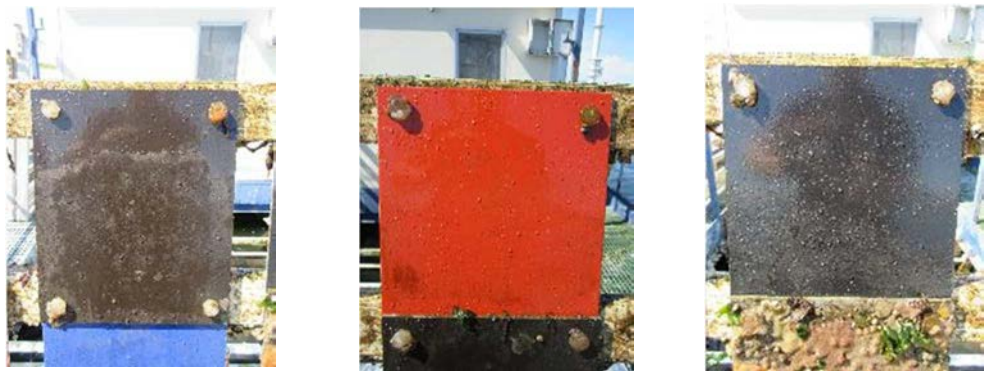
The systems Silic One, Renolit Dolphin S, Bioclean and both types of MacGlide™ foils, all of these products are based on silicon containing top layers, only have thin slime fouling in variable degree (see Figure 11). Panels with Melkfett are also almost clean, only small parts of the panel surface were covered with thin slime. On both panels colonial tunicates were found growing around the edge of the panel (see Figure 12). These organisms are

Figure 11. Detailed pictures of panels with Renolit, Silic One and Bioclean (from left to right).

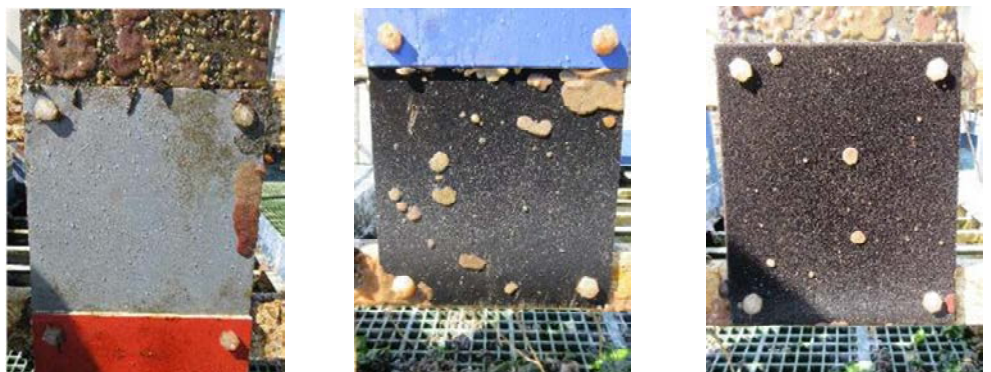
neglected in the evaluation because they have not settled on the Melkfett surface but rather at the untreated back side of the panel. The panels with Finsulate showed start of growth of mainly colonial tunicates on both the short and long version (Figure 12).

Figure 12. Detailed pictures of panels with Melkfett, Finsulate short and Finsulate long (from left to right).

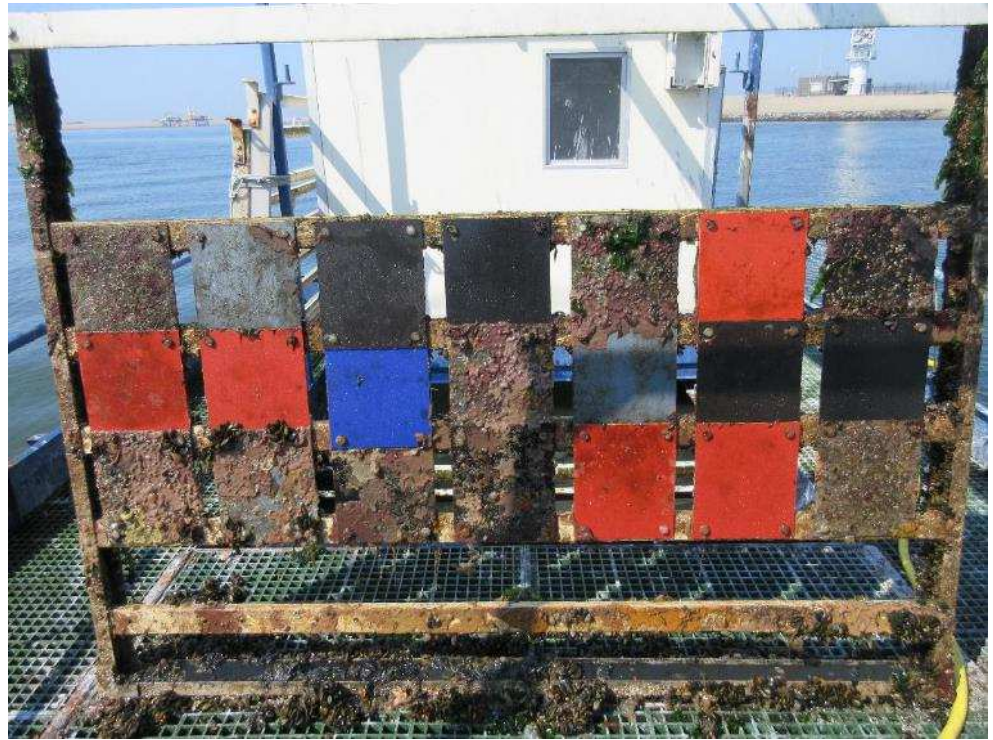
One month later at the next inspection the general picture on panel performance has not changed so much (see Figure 13). Overall the silicon based systems still show good efficacy against macro-fouling although some minor differences are starting to appear. For instance panels with MacGlide™ Pyramidal foil are doing better than panels with MacGlide™ foil: on the latter start of growth of some encrusting bryozoans can be seen (see Figure 14).

Figure 13. Panels with antifouling products at third inspection on August 26, 2019.

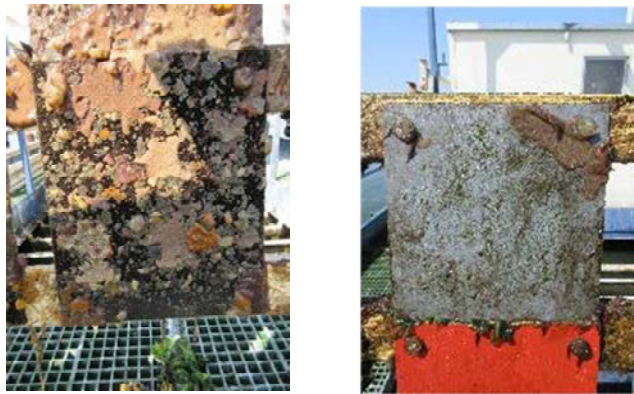
The top panel with Melkfett shows next to slime fouling also green algal fouling (see Figure 15, right) and the panels with Finsulate are now almost fully covered with colonial tunicates.

One of the Finsulate panels is shown in Figure 15. Striking observation is that underneath the tunicates no barnacles are found in contrast to the fouling observed on panels with non-effective systems and blank PVC where the barnacles are very abundant.

Figure 15. Detailed pictures of panels with Finsulate long (left) and Melkfett (right).

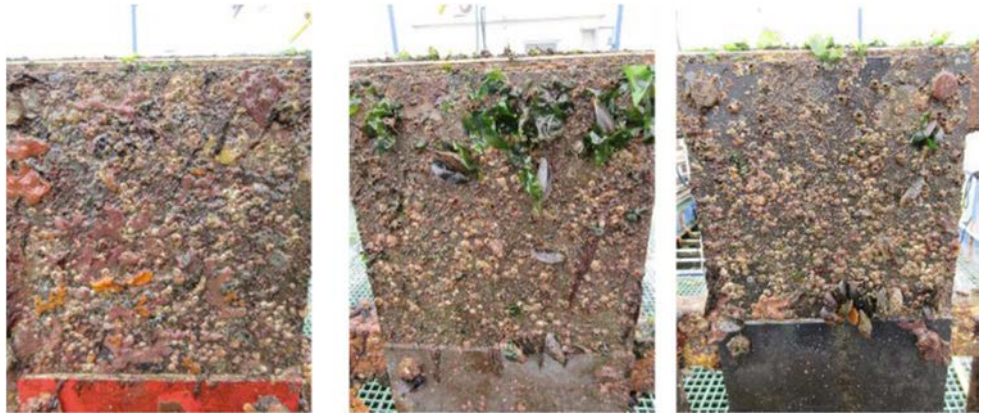
Similar fouling patterns were found on panels with products GPN and Seajet ex3.

Clear pictures of such fouling patterns are given in Figure 17 with one panel of each of these products.

Figure 17. Detailed pictures of panels with PVC, GPN and Seajet ex3 (from left to right).

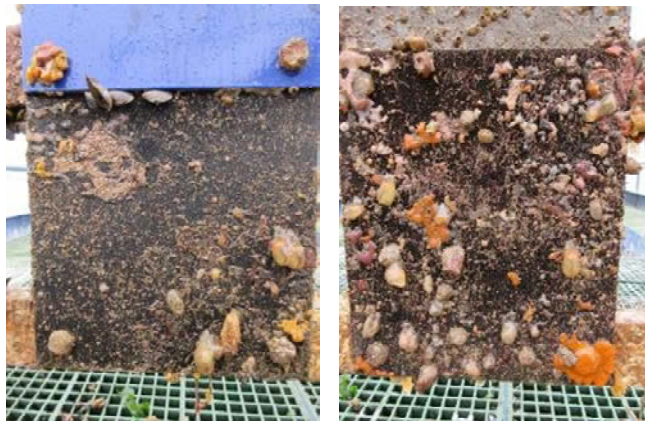
The panels with Finsulate foils also show substantial coverage with macro-fouling, especially colonial tunicates on 40 - 50 % of the surface and 20 % hydroids. Next to this also single adult tunicates (*Ciona*) were found (see Figure 18).

But an important difference with the PVC and other panels mentioned above is that the Finsulate panels do not contain any barnacles.

Figure 18. Detailed pictures of panels with Finsulate short (left) and Finsulate long (right).

The product Finsulate was tested in two versions in the raft test, one panel with short fibres and one panel with long fibres. Both panels showed relatively rapid fouling development during the season with a variety of macro-fouling organisms but dominated by colonial tunicates. In contrast to the blank PVC panels on which high numbers of adult barnacles were found, the panels with Finsulate did not show any barnacle fouling at any time during the season.

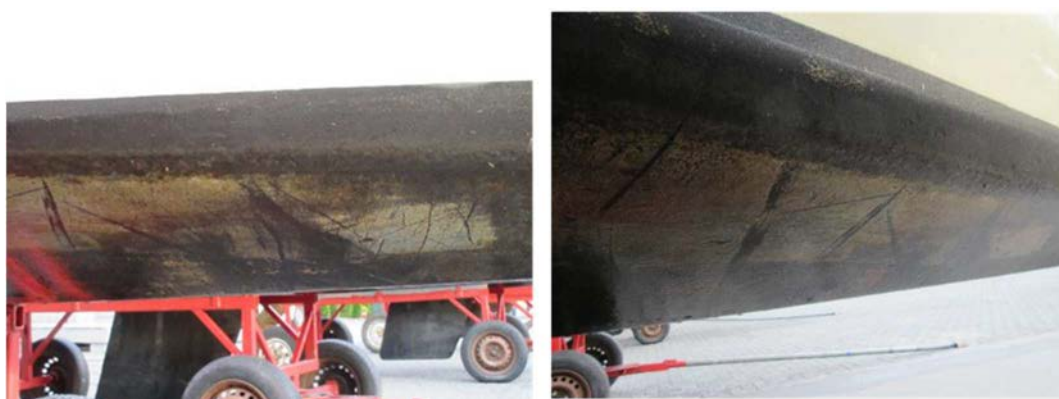
The hull of this boat has only limited slime fouling at the waterline; the fatty product shows patchy distribution and partial brownish or bluish discoloration (Figure 22).

Figure 22. Boat with Melkfett product at the final inspection.

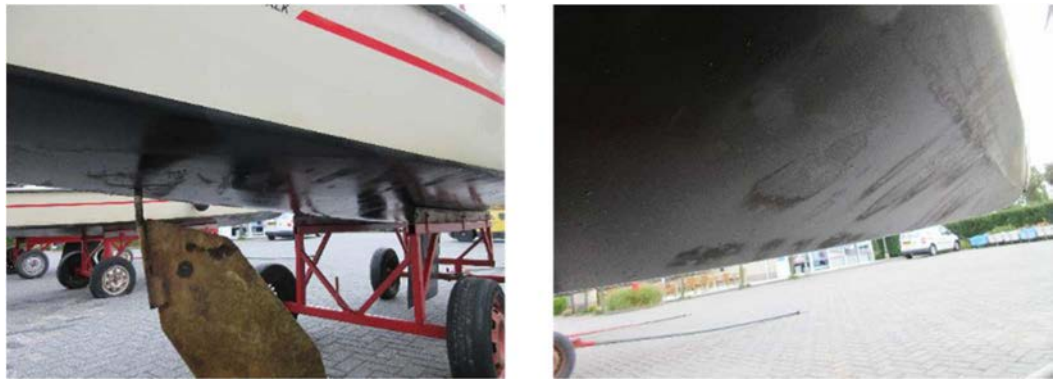
Except for thin slime along the waterline, the hull of this boat was largely free from fouling. The right picture in Figure 23 shows a few spots on the hull where the coating had partially detached as reported in the first inspection on July 4, 2019. Nevertheless, no other fouling than slime was present.

Figure 23. Boat with Bioclean product at the final inspection.

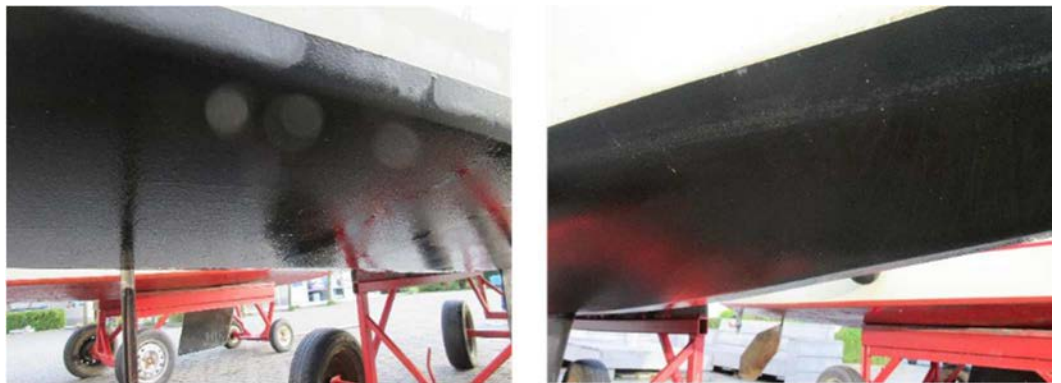
This (self-polishing) product has kept the hull of the boat almost free from fouling except for some slime patches at the waterline. In the left picture in Figure 24 it can be seen that the coating shows some roughness, probably caused by the small blisters that were detected during the first inspection of this boat.

Figure 24. Boat with Seajet ex3 product at the final inspection.

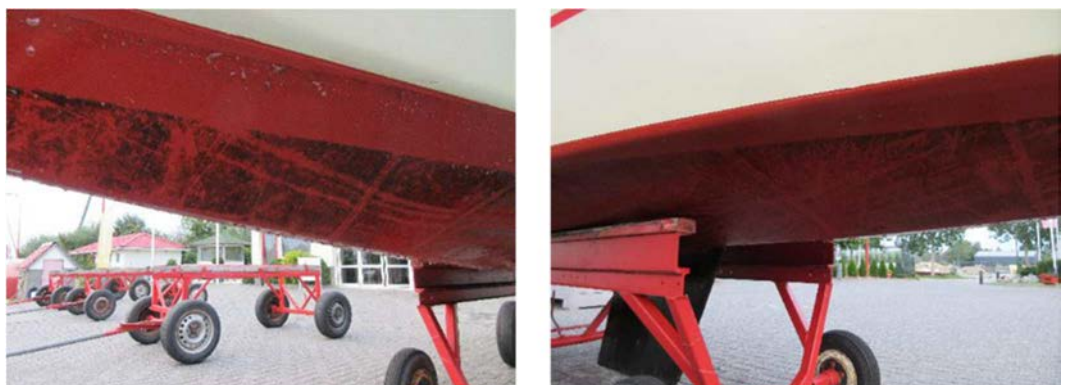
Both pictures in Figure 25 clearly show the presence of a slime layer at a large part of the hull. Due to the red colour of the product this dark slime layer obviously can be seen much easier than on the black products on the other boats. As mentioned in Table 2, the slime can easily be wiped off by hand as long as the hull is wet. In dry condition the slime layer is more difficult to remove.

Figure 25. Boat with MacGlide™ Pyramidal foil at the final inspection.

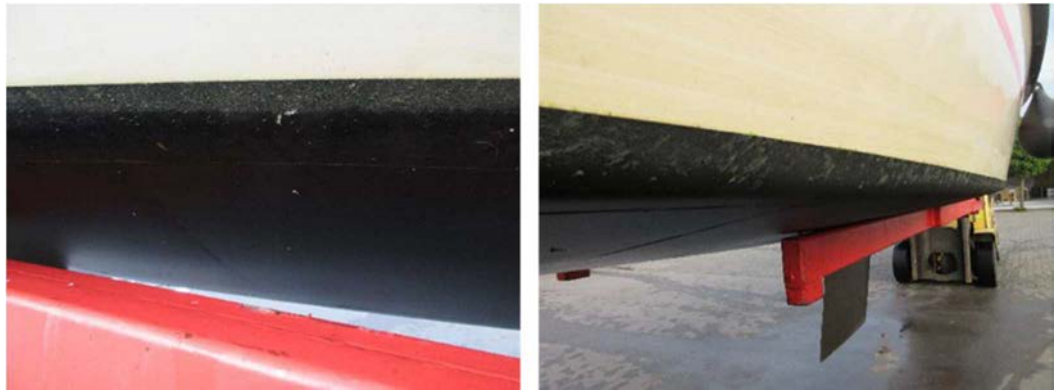
This boat was only inspected twice because at first inspection it was not yet available. Figure 26 shows that the underwater hull of this boat is free from fouling; the only area where fouling is present, is the waterline where relatively short algal filaments were found that had settled between the fibres of the Finsulate product. At the time of inspection the algal threads were shorter than 1 cm but they may grow larger with longer exposure times.

Figure 26. Boat with Finsulate product at the final inspection.

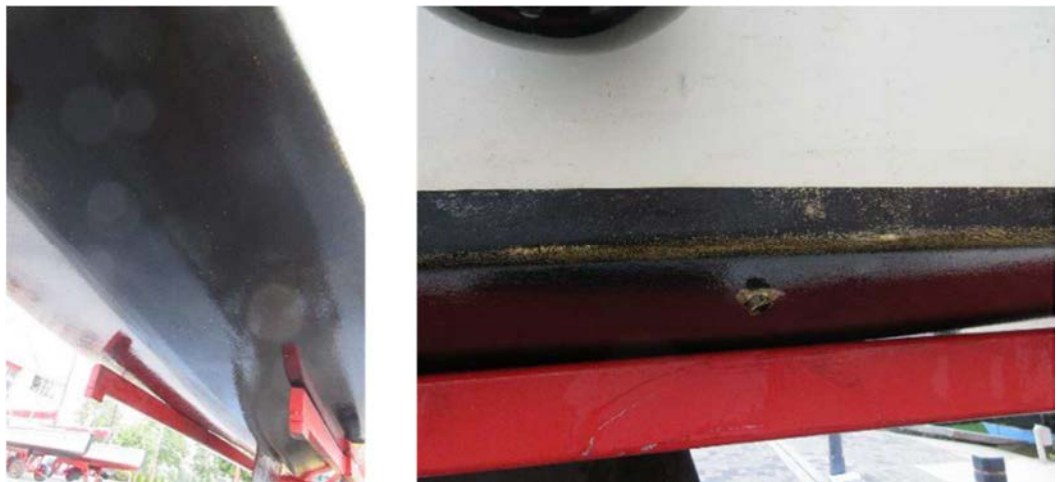
The hull condition of these boats (two different boats were inspected on August 15 and September 24) is good; except for some slime patches along the waterline hardly any fouling was present (see Figure 27).

Figure 27. Boat with reference product at the final inspection.

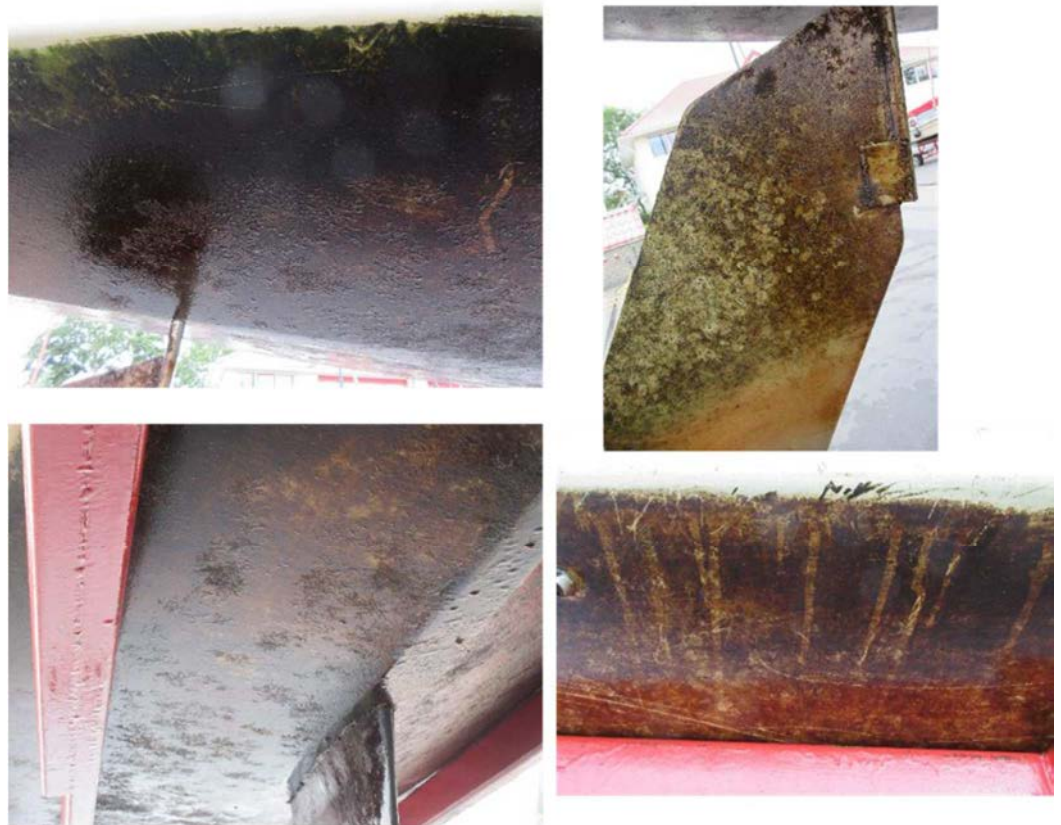
The pictures shown in Figure 28 clearly indicate that a boat without antifouling product on the hull suffers from substantial fouling development. At start of the season the boats were clean. In the course of the year a brown and green slime layer builds up to a thickness of one or more millimetres and therein colonies of hydroids or algal organisms may develop. In one such colony a few small fresh water mussels were also found.

From these pictures it can be concluded that doing nothing against fouling at (this) fresh water location is not a good option. This boat should have been cleaned during the season with the brush installation Ottenhome has available.

Figure 28. Compilation of pictures of the hull condition of a boat without antifouling at the fresh water location in Heeg.

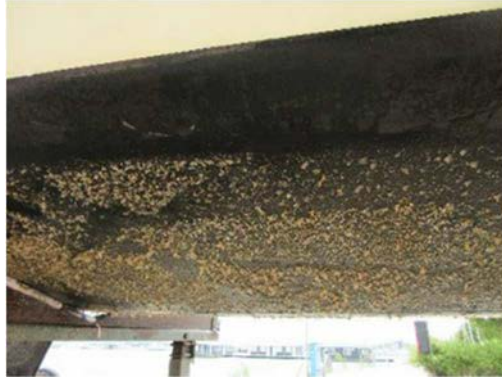
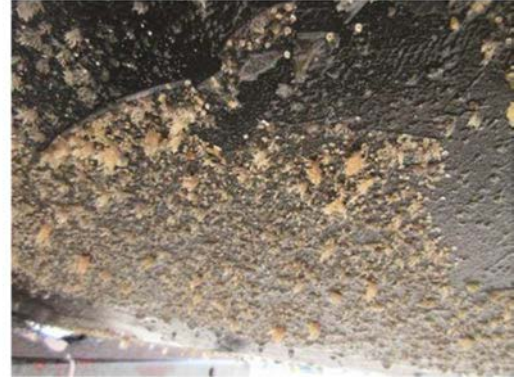
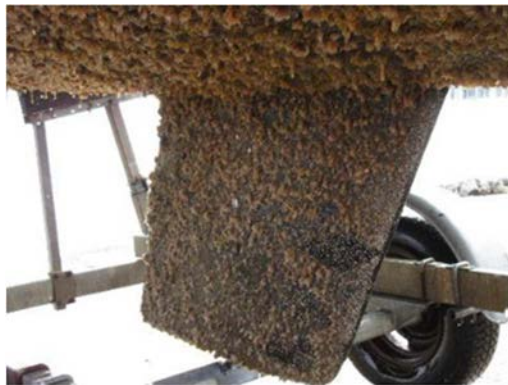
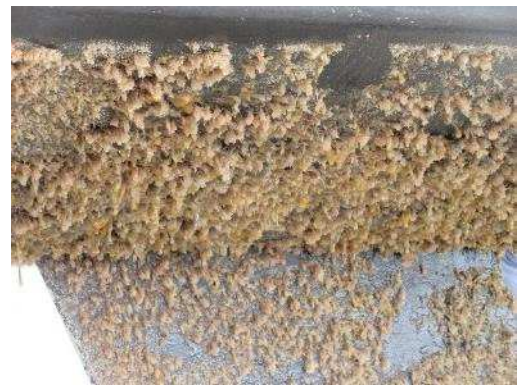
This product failed early in the season due to a mistake at application of the paint. After two inspections, the boat owner decided to remove the Bioclean product and replaced it by the reference paint. This boat was not further inspected.

Because of the application failure this boat gave a perfect impression of the strong fouling conditions present at this location early in the season. The location Bruinisse belongs to the lake Grevelingen in the province of Zeeland, a lake generally known for a bad water quality with very low oxygen content.

The boat initially provided with the product Bioclean, which failed because of a mistake during application, clearly indicates that the fouling pressure at this location is much higher and much more diverse than at the fresh water location.

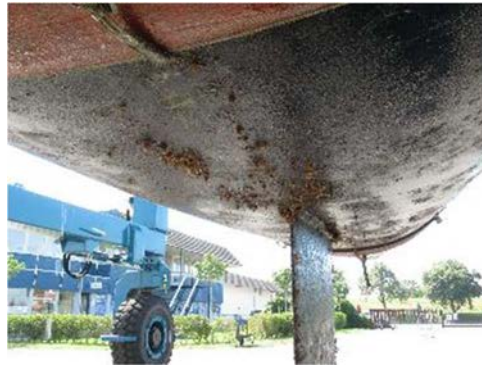
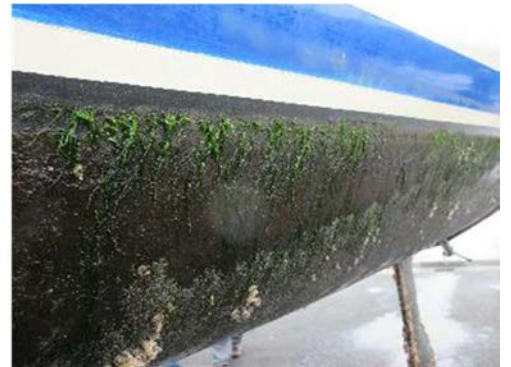
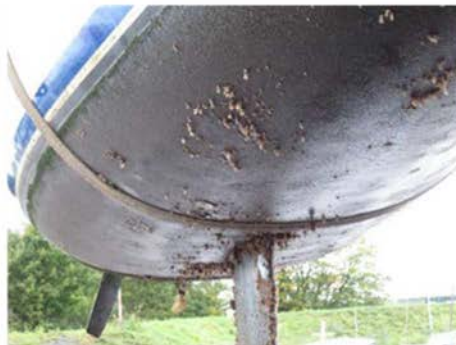
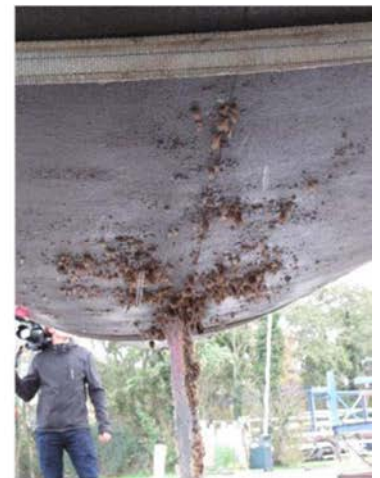
In the beginning the hull was entirely clean, about half way of the season some local spots with barnacles and a green algal beard at the waterline (see picture August 23) were found.

Later on (September 19) thick slime fouling was present at the waterline and the transducer was found to be switched off. At the end of the season about 50 % of the underwater hull was covered with thin grey hydroid (relatively easy to wipe away by hand) and local spots of barnacles were found with estimated coverage of 15 %. Barnacles and algae were not so easy to remove by hand.

The two ultrasonic systems showed slightly different performance with Sonihull (two transducers, one on each side) a little bit better in the second half of the season, but it cannot be excluded that Shipsonic (only 1 transducer) performed less because this transducer was found to be switched off for some time between the third and fourth inspection.

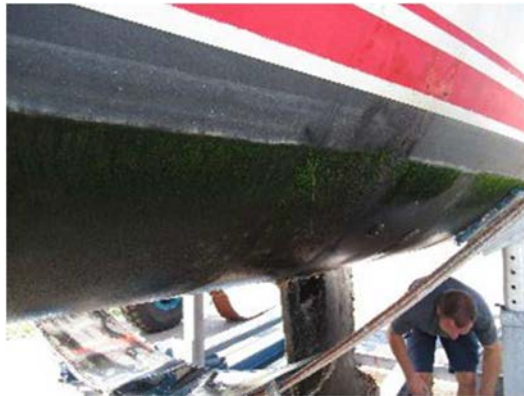
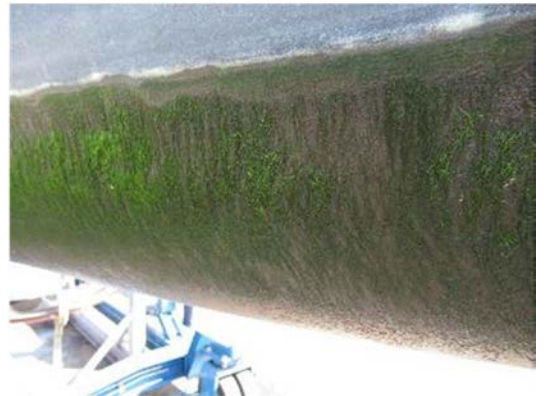
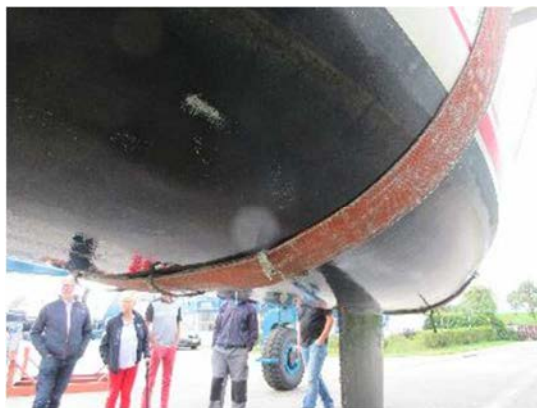
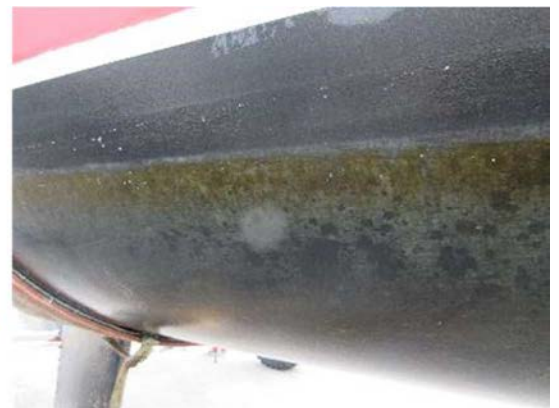
In the beginning the hull was entirely clean, later on in August a strong beard of green algae had developed along the waterline. Because of a broken strut that needed repair, the boat stayed out of the water for about a week.

In September dark slime was present and the algal beard was less prominent. At the end of the season the boat was (still) free from hard fouling but about 10 % of the hull was covered with thin grey hydroid and next to this green algal filaments (10 – 15 cm long) were present at parts along the waterline. The soft grey hydroid was relatively easy to wipe away by hand.
