Combating marine growth from fresh water

Preventing blockages in pipework

In this case study we discuss the RWS monitoring station in Eijsden. Since 1974, this floating pontoon has been carrying out 24/7 measurements to analyze the water quality.

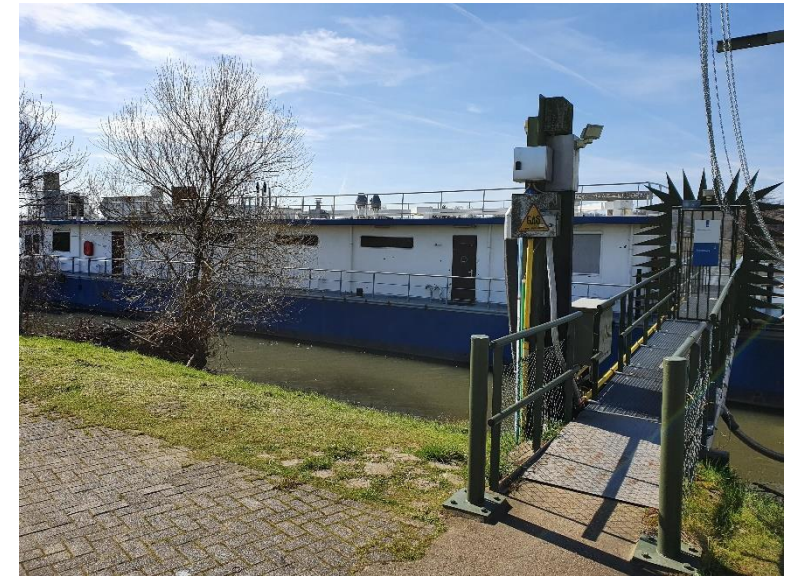
The RWS monitoring station in Eijsden

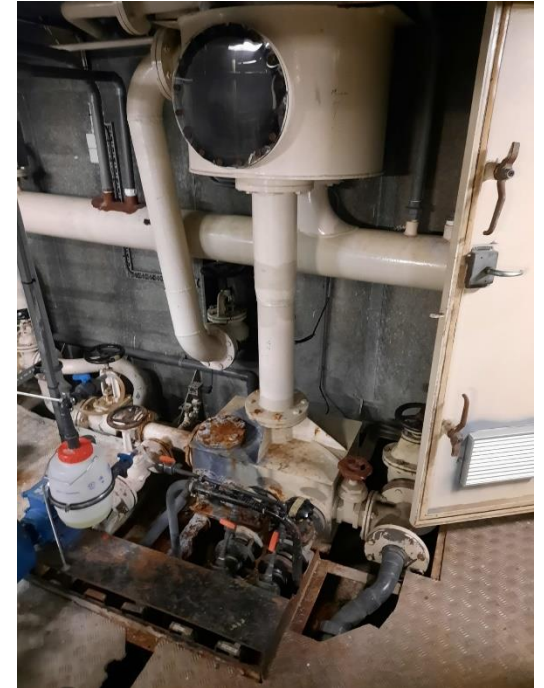
The system that sucks up the water that has to be measured is constructed as follows: suction pipe, filter, pump, branches and a discharge pipe in case the water pressure is too high.

The sampling is done from several branches of a suction pipe, through which the fresh river water of the Maas flows. This pipe system, and in particular the drainage system when the water pressure is too high, closes up on the inside, so that the flow in these systems becomes less and less. The fouling accumulates against the walls of the pipes, especially in bends or after valves. One of the marine organisms that settled in the past were freshwater mussels.

Part of the sampling system

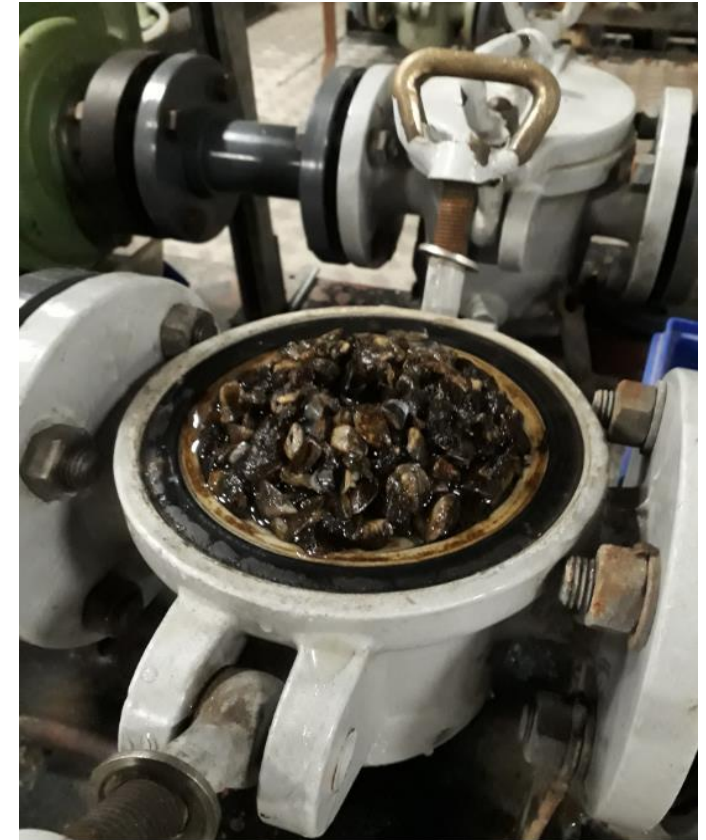
Due to this fouling problem, the piping had to be cleaned every day (!). It seemed that mussels developed in the pressure tank, which were then regularly flushed through the installation by the flow. As a result, the pipes and filters became clogged every day. Mussels quickly develop into adults specimens in warm waters.

The filter for the distribution pumps can be seen on the right. The filter had been full of mussels every week during the problem. This was the result of accumulations of mussels, which occasionally come loose and end up in the pipework and clog the filters and pipes.

Clogged distribution filter

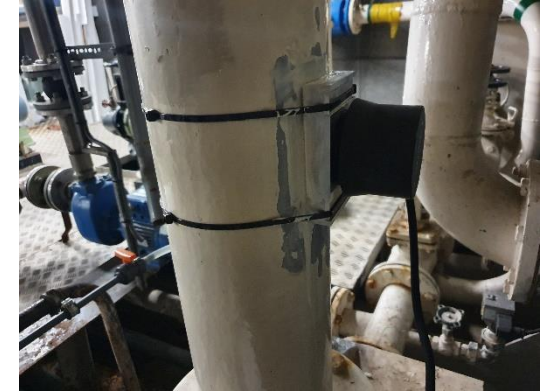
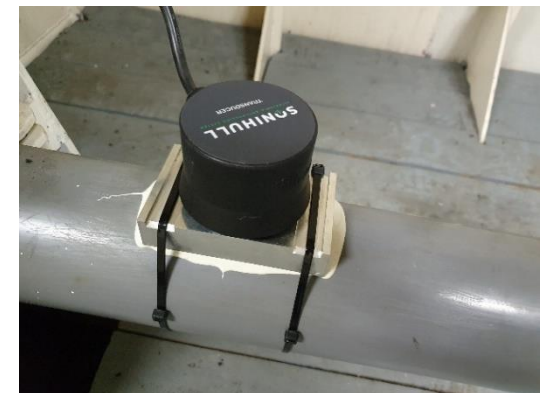
A transducer is glued to the pipes with the most problems, which ensure that fouling remains gone. The pipework amplifies the signals: both the rigid construction and the water flowing through it function as a carrier of the sound. As a result, the entire sample monitoring system is protected by means of the Ultrasonic signals.

Transducer on a pipe with a pipe adaptor

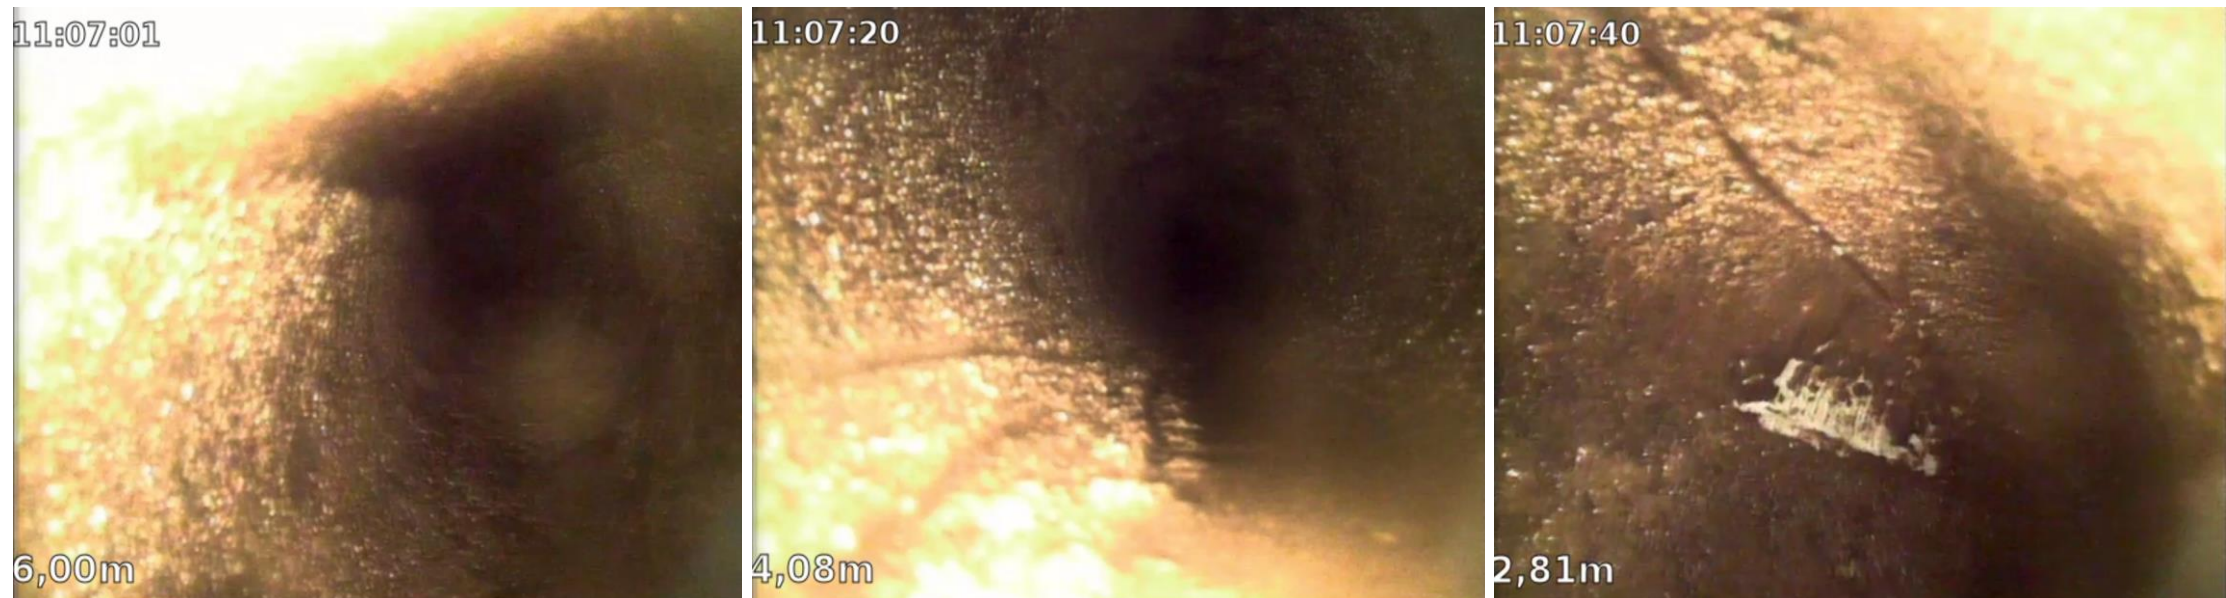
Below are some snapshots taken from a video made with an endoscope. These images were taken 11 months after installation. The piping is completely clean, there is no visible marine growth that could restrict the flow. The unevenness that can be seen is the irregular structure on the inside of the piping.
