Case Study: Box Coolers and Sea Chest

Royal IHC builds, among other vessels, standardised Trailing Suction Hopper Dredgers (TSHD). One of these lines is called the Easydredge®. The sea water cooling system that is installed on the Easydredge® 2700 uses box coolers to provide cooling for their main equipment. These coolers are at all times in direct contact with raw sea water. In order for this system to be efficient, antifouling paint cannot be applied to the cooler bundles. This would mean the heat transfer from the cooling liquid would be less optimal, as the antifouling paint would act as an insulator. Only a thin anti corrosion coating is applied.

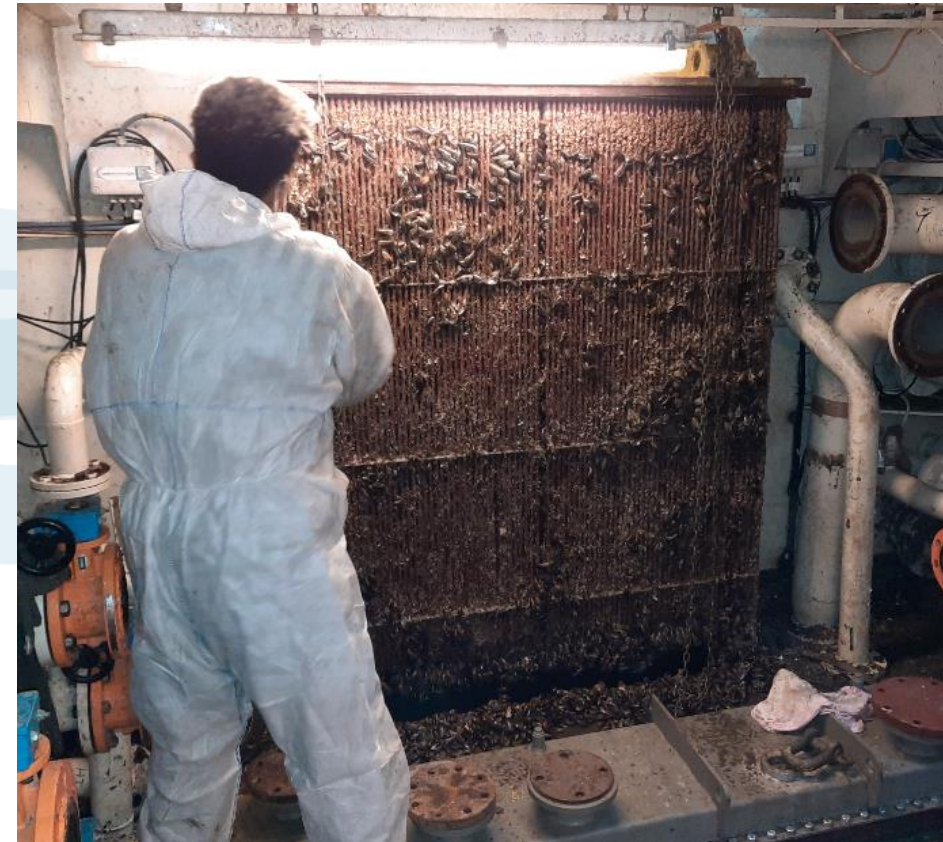
Time-consuming, heavy labour is required to clean the box cooler. This is an example and is not from a Royal IHC ship.

Additionally, these fouling related problems could lead to **unexpected dry dock & downtime**. When the box coolers are clogged expensive and time-consuming maintenance is necessary to get rid of the excess fouling.

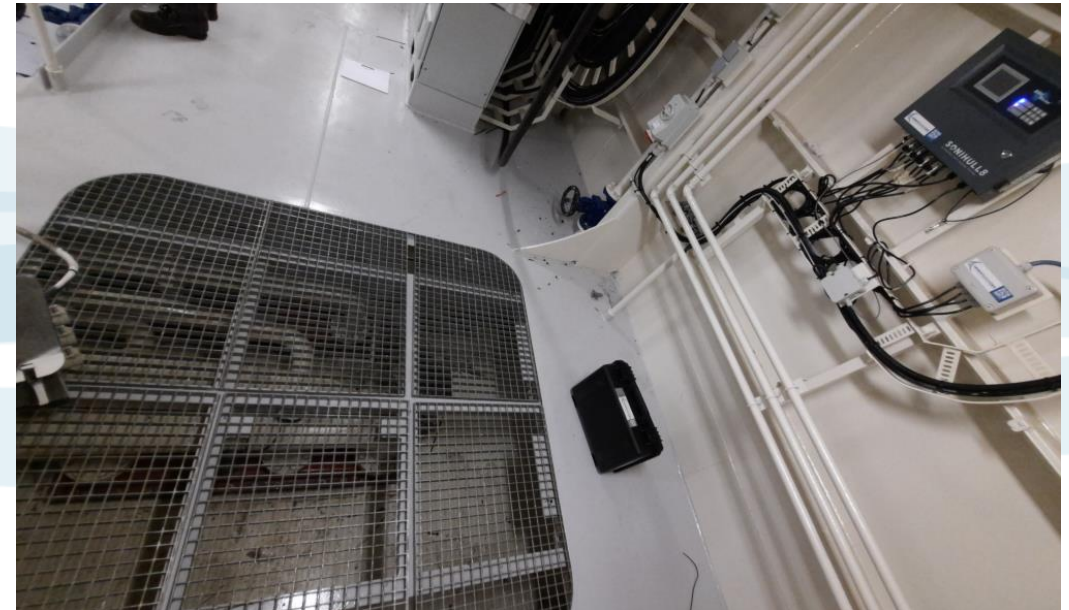
The installation as carried out on the TSHD. On the upper right, the control unit is visible, located above some of the box coolers.

The SH08 control unit can be connected to both 110-240 VAC and 12-24 VDC. If both are connected the system automatically selects the VAC (shore voltage). When this is lost, the system automatically switches to the VDC. If the battery voltage becomes too low the system switches off automatically to save the battery. The control unit is programmed in such a way that the transducers run the same program every time. As a result, the transducers produce pulses every few seconds with a range of frequencies between 20 and 60 Kilohertz that are not audible to the human ear. When this program has been completed with 20 different frequencies the program starts again.

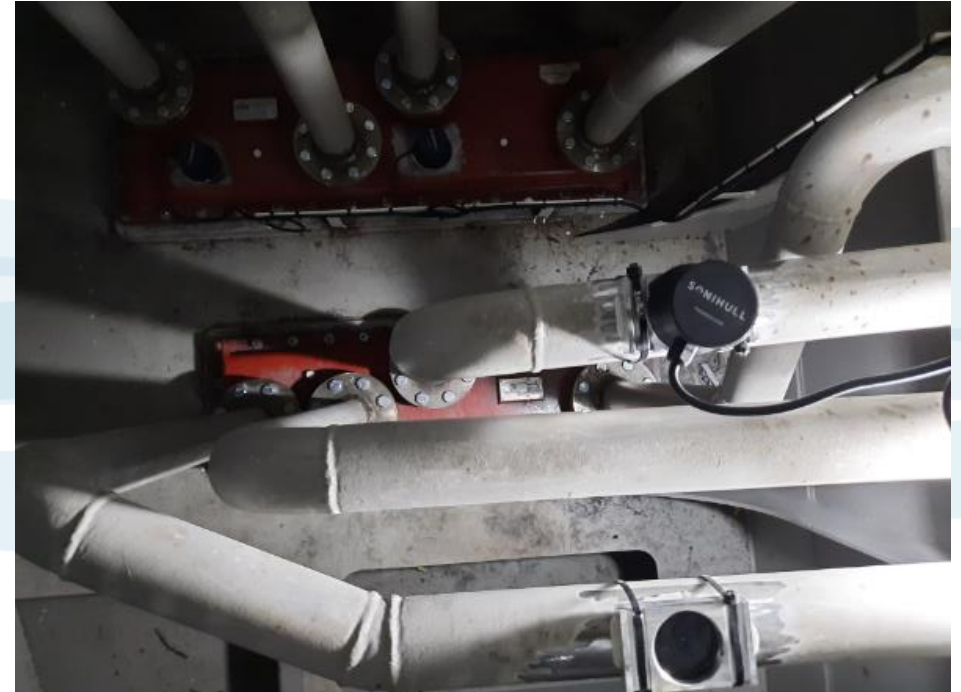
Two transducers are visible on the cooler cover. Two Pipe Adaptors can be seen in the picture, one of which has a transducer screwed into. To ensure optimal adhesion of the two component epoxy coating is removed. Following the curing of the epoxy, primer is applied to prevent corrosion around the mounting objects.

The transducers consist of a piezo element that is enclosed in a housing produced by means of injection molding. The transducer is then screwed into a mounting object (pipe adaptor or transducer ring) with a coupling agent. The mounting object is installed with a two two-component epoxy.

In this case the pipe adapters and transducer rings are installed on box cooler covers, cooler inlets and the sea chests. The membrane of the transducer is not glued to this surface itself, the ring or pipe adapter is. The transducer uses this ring or PA as a grip so that it can distribute firm taps with its pulses.

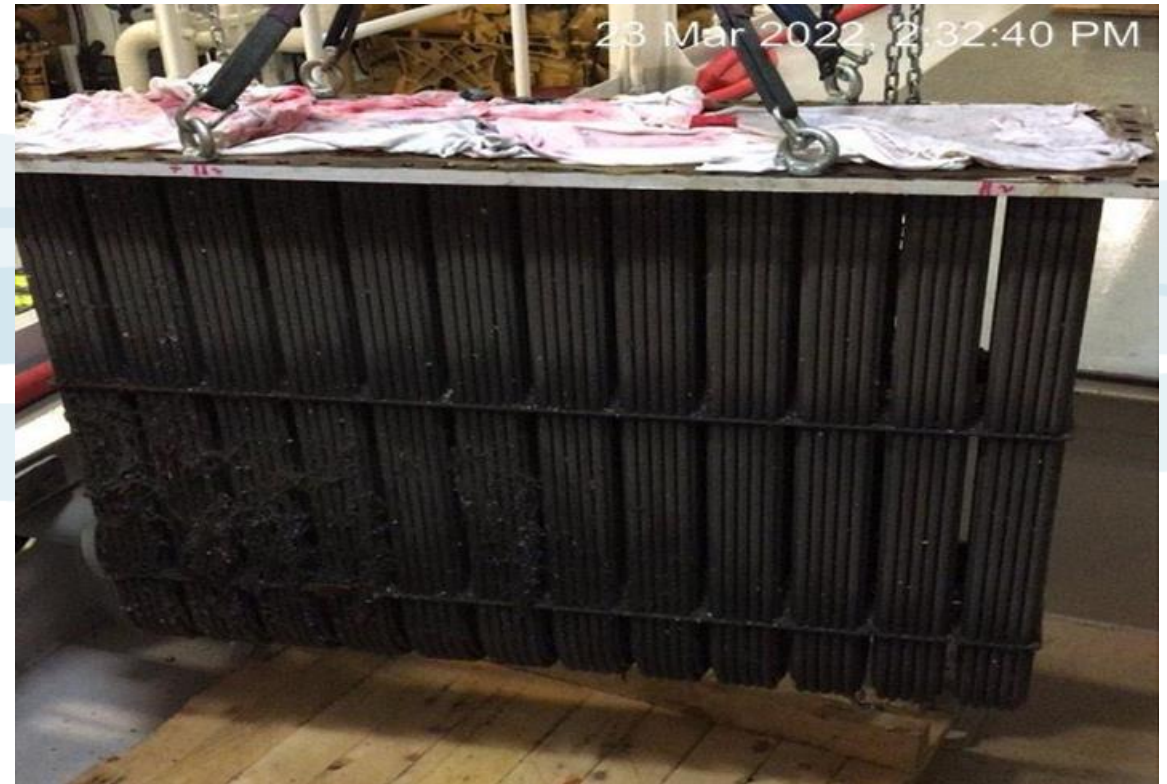
After 2 years of sailing no hard fouling is visible on the box cooler bundle. On the bottom left of the cooler some dead marine growth is attached but can easily be wiped off.
