Case study "boxcoolers fishing vessel"

The fishing boat treated in this case mainly sails in the North Sea: salty, fouling-sensitive waters. The vessel has a seawater cooling system consisting of three box coolers (one PS, two SB).

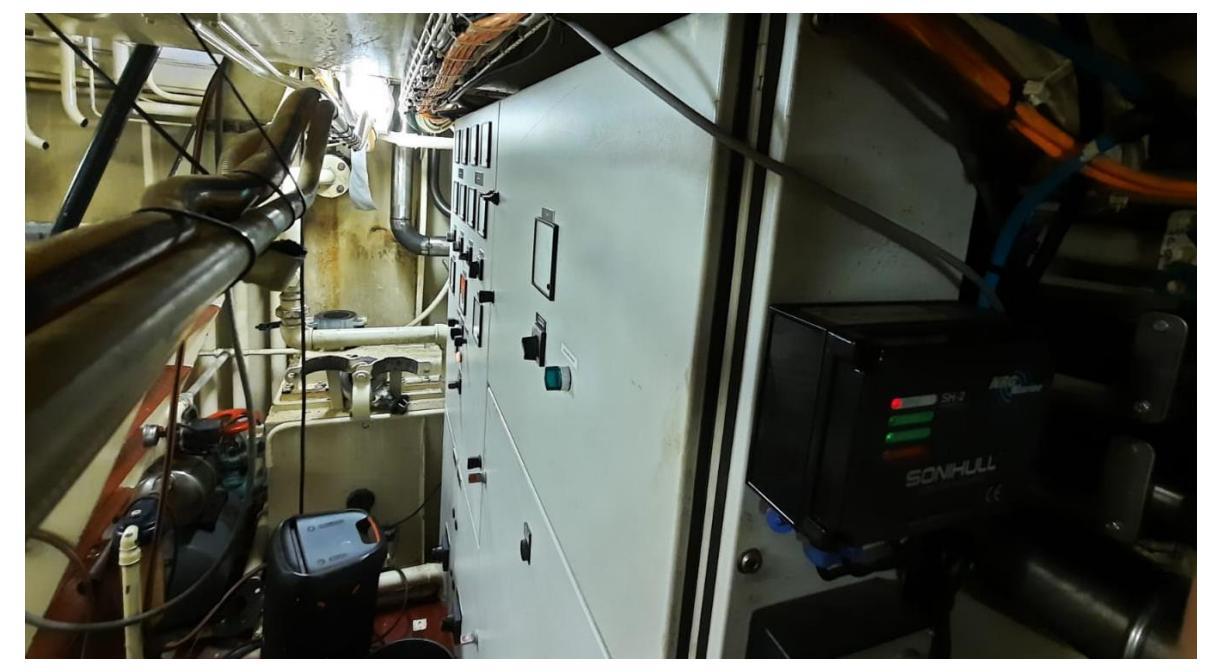
In October 2018, the SH02 system was installed on the port side (2 transducers). One transducer is installed on the cooler lid and one on the side of the seachest. The vessel had just been cleaned at the time, which is a precondition for proper functioning of the Ultrasonic Antifouling System. There has to be started clean, to keep it clean.

One SH02, with the seachest in the background

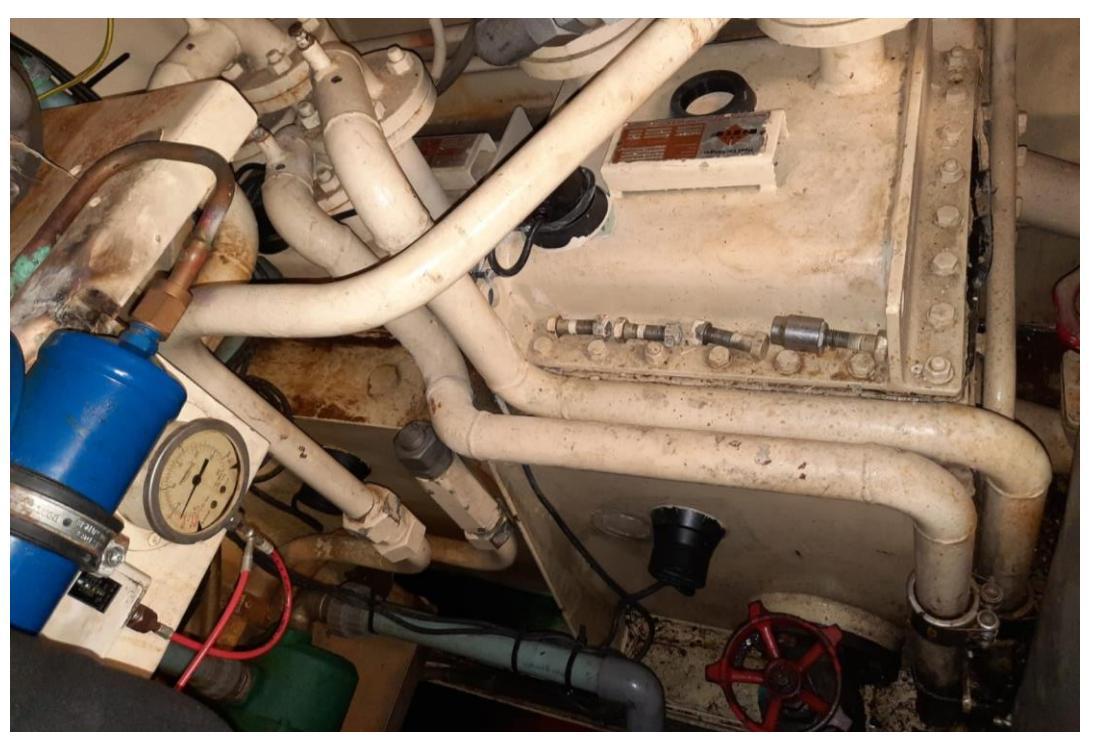
In May 2019 2 x SH02 (4 transducers) was installed on the starboard coolers and seachest after the vessel had been sailing for 8 months without protection. One transducer was installed per individual cooling circuit and two on the side of the seachest.

Installation on starboard

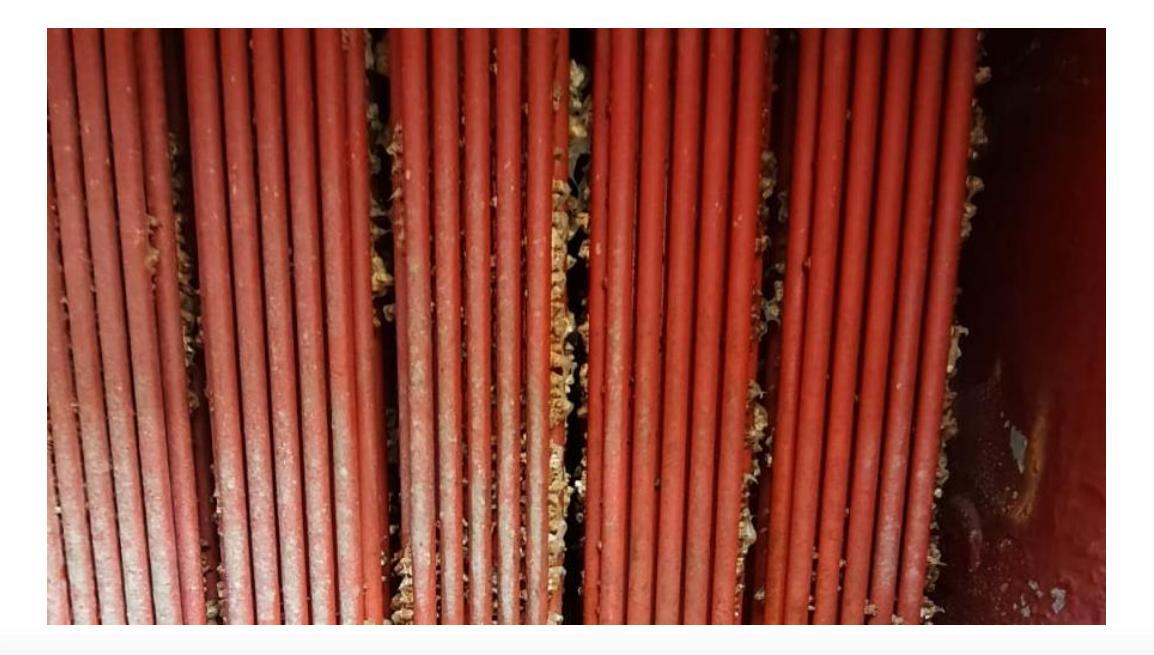
Port side cooler condition after 31 months: The cooler is clean except for some outer pipes (of each cluster of 5 pipes). There was an amount of hard growth on it. These do not impede the flow through the box cooler and therefore do not cause a loss of heat transfer.

The port side coolers have remained largely clean and have not caused any cooling problems. The coolers on the starboard side have considerably more fouling on the coolers than on the port side and will unfortunately have to be replaced. The difference in fouling is of course due to the fact that the coolers on starboard side weren't clean from the start.

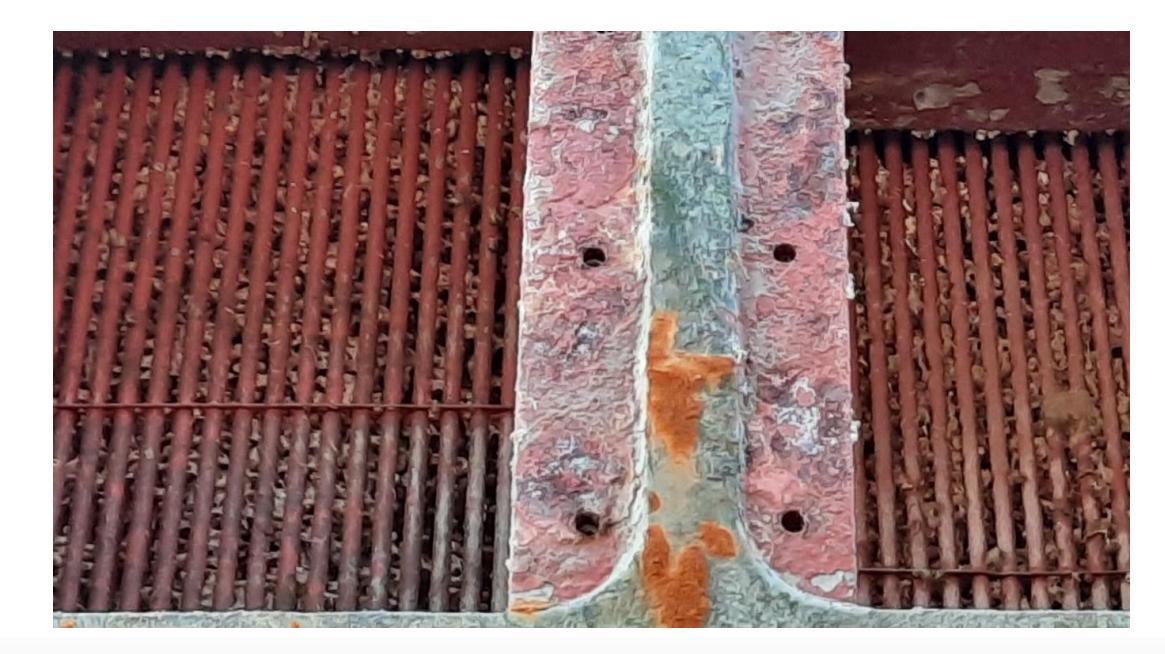
The condition of starboard side coolers 23 months after installation: There is a lot of fouling in the bundle between the pipes, in contrast to the cooler on port side. A lack of flow through the cooler bundle eventually leads to too little heat transfer to the water and thus to cooling problems.
